East Wichel Canal – July 2022 Update

In May 2022 further investigation works were completed on the East Wichel canal. This update provides a summary of the findings and describes the next steps.

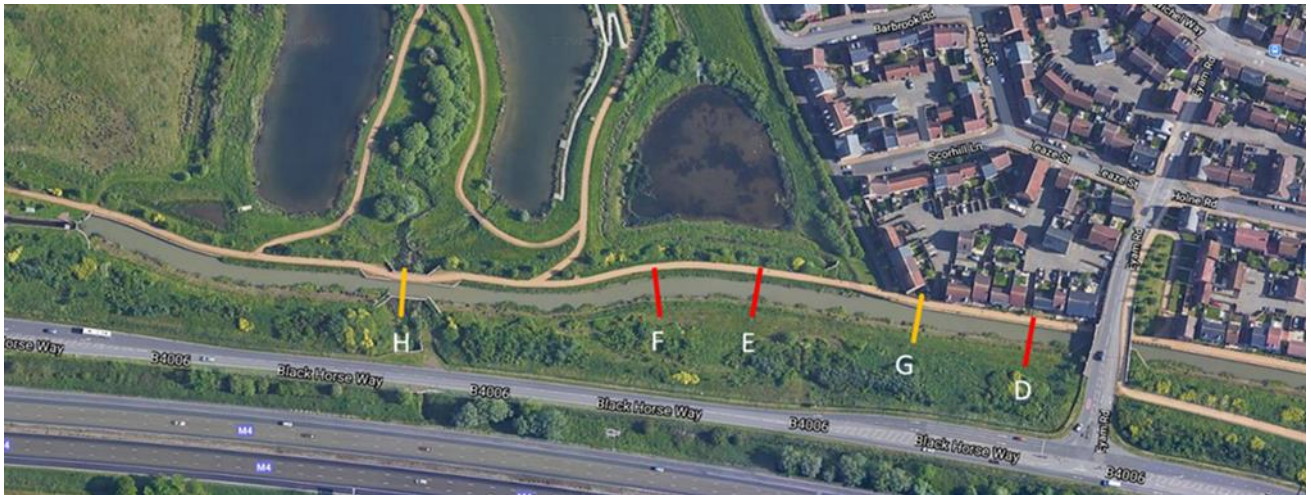
1) Section E to G

Area E to G has been the main area of focus with a significant leak in the base fixed last year. This had prevented this section from emptying completely but water has continued to drop each time the canal has been re-filled, levelling out at around half full.

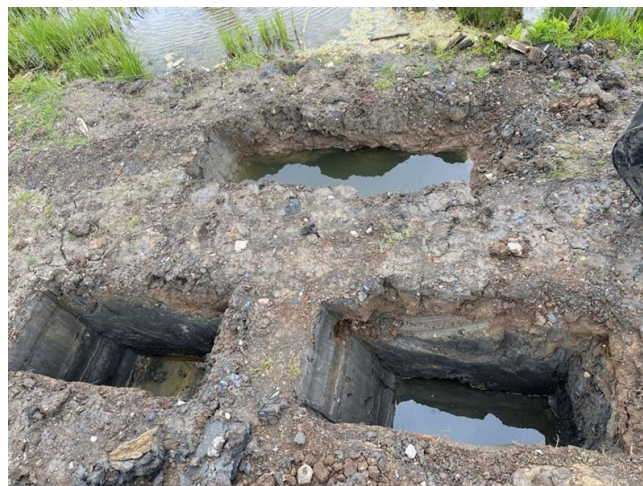
A series of test pits were therefore dug both sides of the canal and monitored to see if they would fill with water. This would indicate whether water was passing through the banks of the canal, and if so where.

One of the southern pits filled to the same level as the canal within 24 hours and another two pits on the southern bank filled to the canal level within a week. It was therefore concluded that the clay lining on the southern bank towards bund E was not watertight. The two pits dug on the south bank closest to bund G remained dry.

The canal will be drained and approximately 45m of the southern bank relined with clay. The canal will then be re-filled as far as possible and monitored.

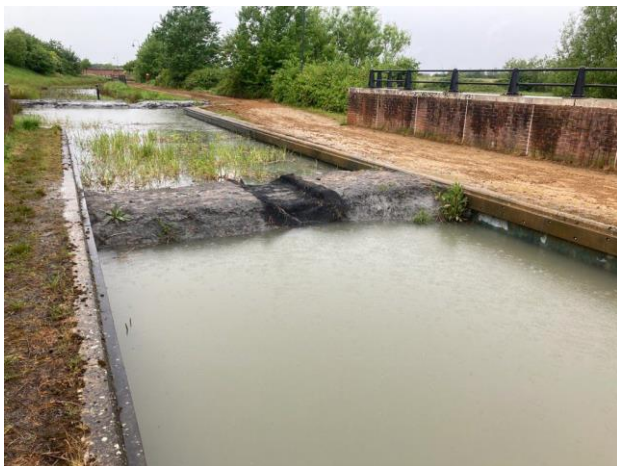
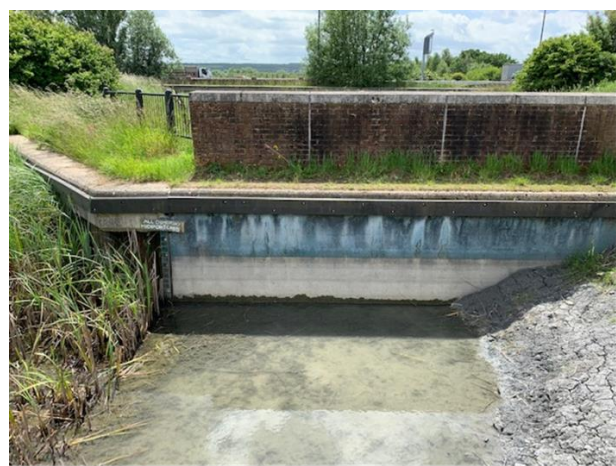
The photos below show the water at the point the bunds were installed and then again a couple of weeks later.

The water in the eastern side (I to H) dropped very quickly and is a clear indication that there is a problem in this section. The western side also dropped, although not as quickly, and may have been impacted by leakage through the bund.

May 2022

June 2022

As part of the next section of works it is intended to look in more detail at the joints between the structure and banks to see if the exact location of the leak can be identified. It is then likely that re-lining works will be required in this section.
