## East Wichel Canal – March 2023 Update

This note provides an update on the works to detect and fix leaks within the East Wichel canal. Previous updates can be found at the following link <a href="https://www.wichelstowe.co.uk/news/east-wichel-canal---spring-2023.aspx">https://www.wichelstowe.co.uk/news/east-wichel-canal---spring-2023.aspx</a>

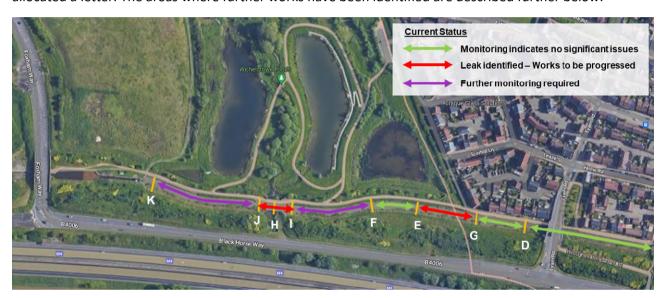
The plan below shows the current status of each section of canal with each of the dividing clay bunds allocated a letter. The areas where further works have been identified are described further below.

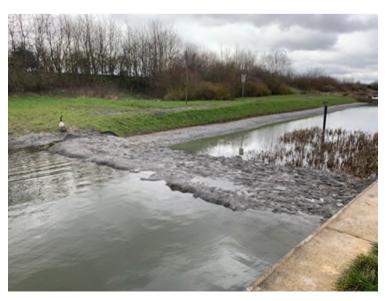
A number of fixes have already been completed in this section, with a leak in the base and through the southern bank repaired. The electronic monitoring of water levels, along with further test pits dug to the south of the canal, have demonstrated that water is no longer leaking from these locations.

It is however clear that this section is still leaking, with water levels noticeably lower than other sections.

Further investigation, including trial pits, has therefore been completed focussed on the north east of the section where no previous remedial works have been undertaken.

This investigation has indicated that water is leaking through the northern bank at the bridge structure and underneath the towpath. Working with the contractor and civil engineers a number of options have been explored to address the issue.

It has been concluded that the most robust solution is to empty this section of canal, dig a trench along the towpath in the affected section, and pour concrete behind the canal wall to form a barrier. In order to complete these works a section of the towpath will need to be closed to allow the trench to be dug and filled. All efforts will be made to minimise the disruption and access to properties fronting the canal will be maintained at all times, either from the east or west.

Following the completion of the works in this section the canal will be refilled and monitored for a period of circa 4 weeks. If the monitoring indicates the fix has been successful bunds D, G and E will be removed.
